Practical Plant Failure Analysis

**A Guide to Understanding
Machinery Deterioration and
Improving Equipment Reliability**

Neville W. Sachs, P.E.

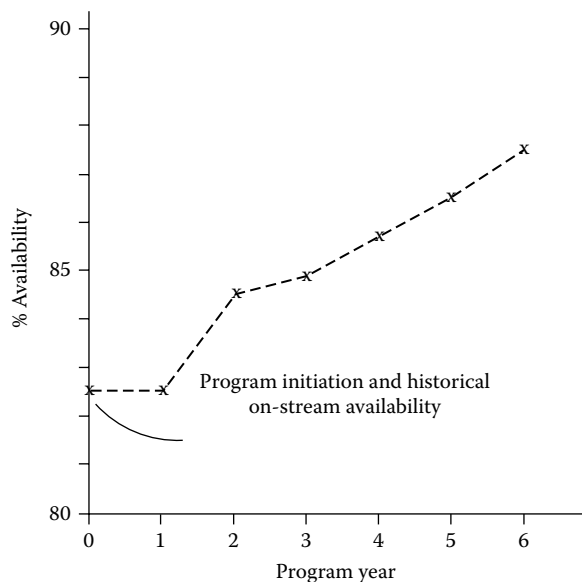
FIGURE 1.2 Equipment availability vs. program year for an effective reliability program.

The plant where I learned about *The Reliability Approach*TM was over 90 years old with a mature process that had not been changed for years. The annual sales volume of the plant was about half a billion dollars, and it had historically lost around 17% of the production capacity to downtime. During the first six years of this reliability program, despite minimal expenditure on capital equipment and a reduction in both the maintenance staffing and the maintenance budget, we were able to increase effective production time by about 1% per year, and the actual output increased by more than that. (The net benefit was about a 1/3rd reduction in downtime for a process that hadn't materially changed in 40 years.) The following graph shows the actual results from the program (Figure 1.2).

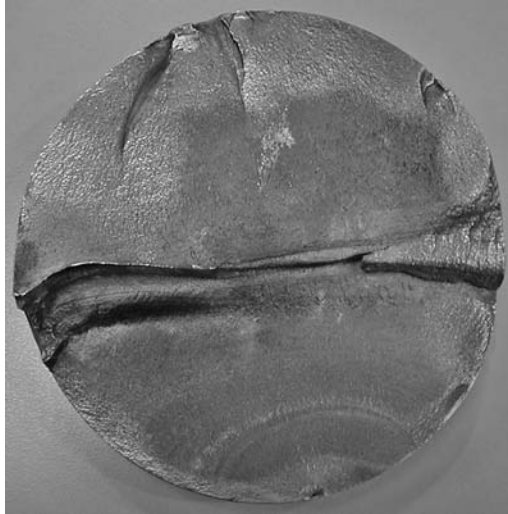
PHOTO 2.1 Fatigue failure of an agitator shaft.

Looking at the failure face and its surroundings will tell almost everything about the physical causes of the failure, i.e., where it started, the magnitude and direction of the forces involved, how long it took to propagate across the piece, and whether there were any material weaknesses that contributed significantly to it. Sometimes it is more difficult than others to see the clues, and sometimes it is difficult to understand all of them, but they are there. Inspection of the failed agitator shaft shown in Photo 2.1 indicates that it was a fatigue failure, was caused by two-way plane bending, had stress concentrations, and was lightly loaded. Further inspection of the shaft exterior surface will present evidence of the faulty maintenance practices that caused the two-way bending.

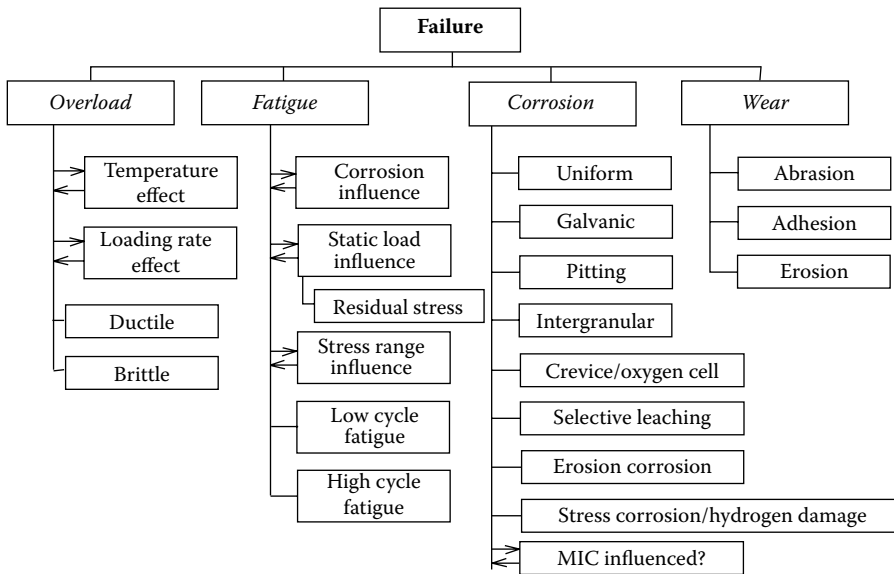
FIGURE 2.4 An expansion of Figure 2.1 showing major failure mechanism contributors.

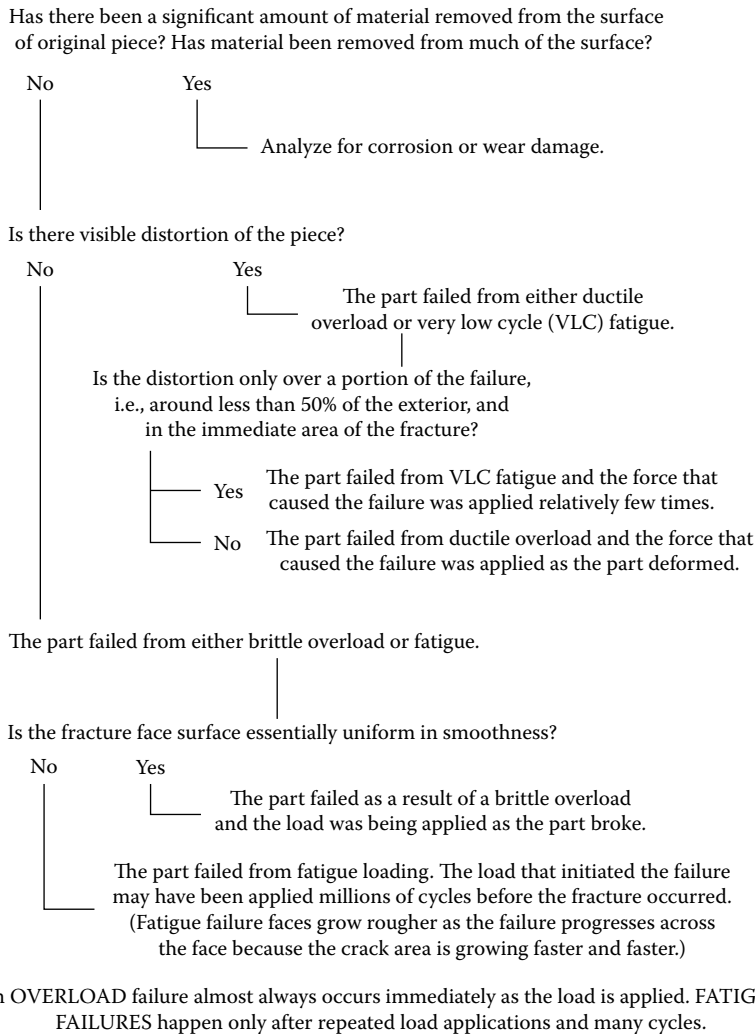
FIGURE 2.5 Determining the basic failure mechanism.

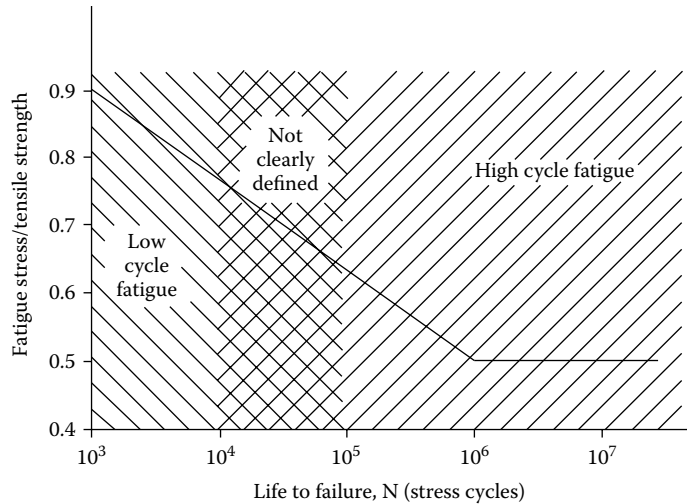
FIGURE 5.1 An S/N chart showing the ranges for low and high cycle fatigue failures. (VLCF would be off the left side of the chart.)

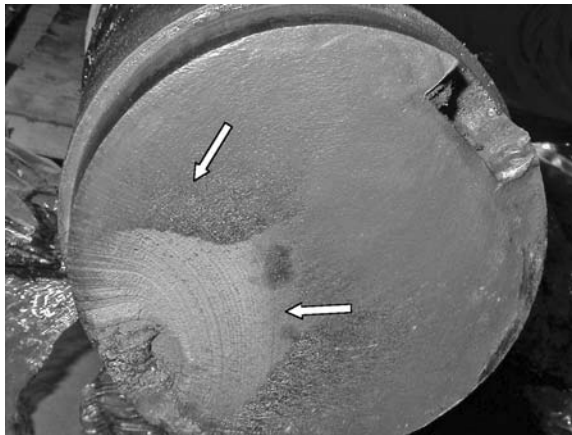
PHOTO 5.1 This fatigue failure started at the keyway. The fracture face is relatively smooth up until the ends of the two arrows. From there to the final fracture progression marks are readily visible.

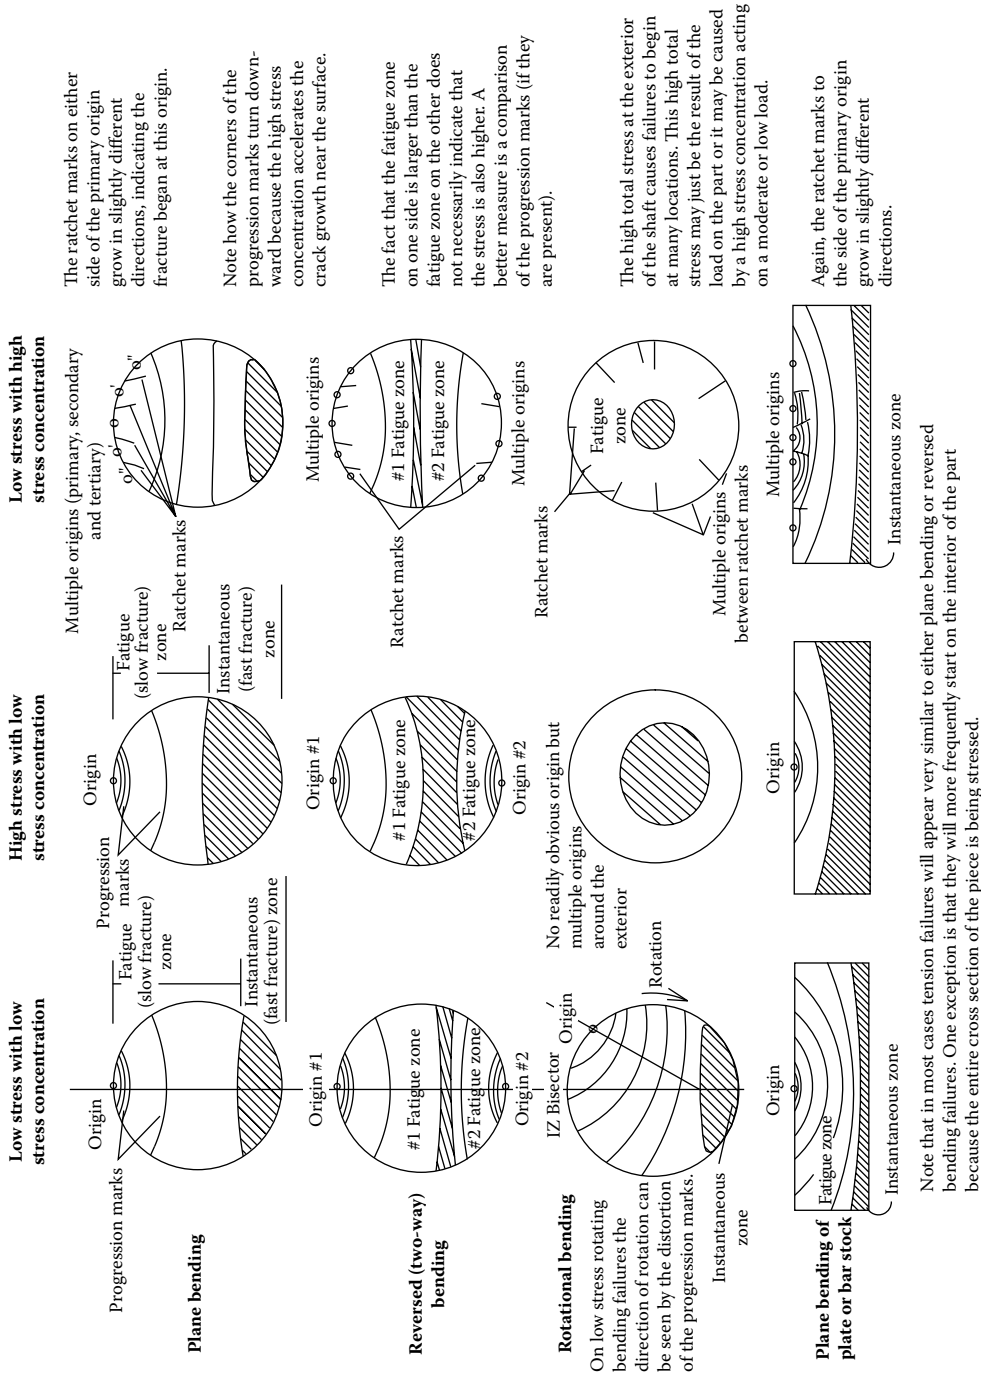
FIGURE 5.12 Fracture face appearances for rotating and plane bending failures.

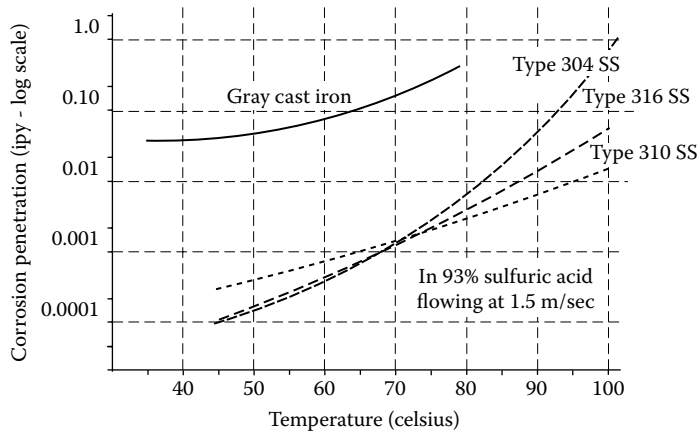
FIGURE 7.9 Corrosion rates vs. temperature for two of the materials shown in Figure 7.7.

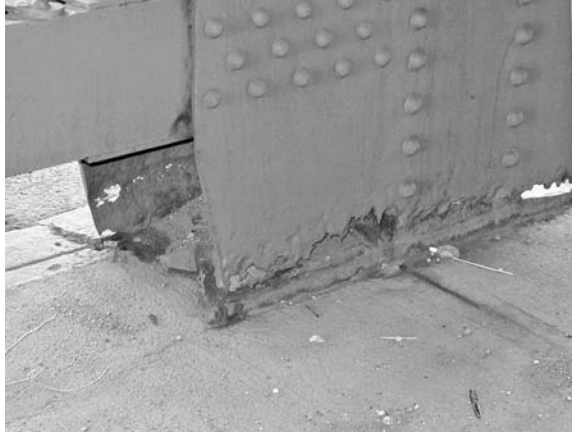
PHOTO 7.2 Moisture and contaminants present in the debris around this bridge support lead to the attack.

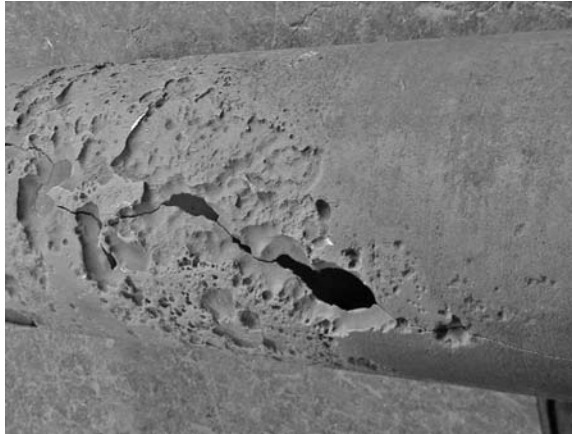
PHOTO 7.8 Selective leaching of a buried pipe.

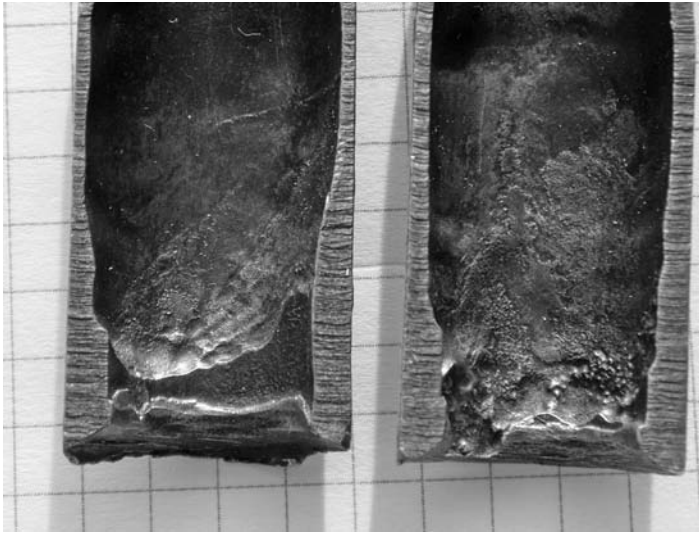
PHOTO 7.10 Erosion corrosion of two heat exchanger tubes.

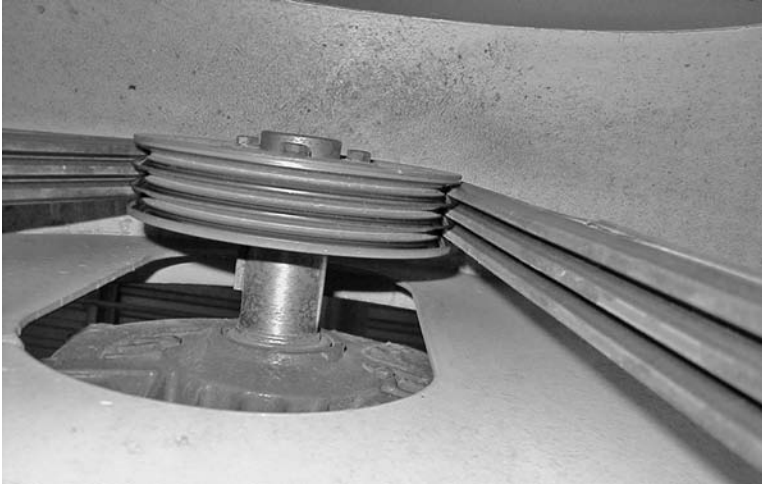
PHOTO 9.3 The cover separation on the right side of the sheave is obvious. This is the result of improper installation procedures.

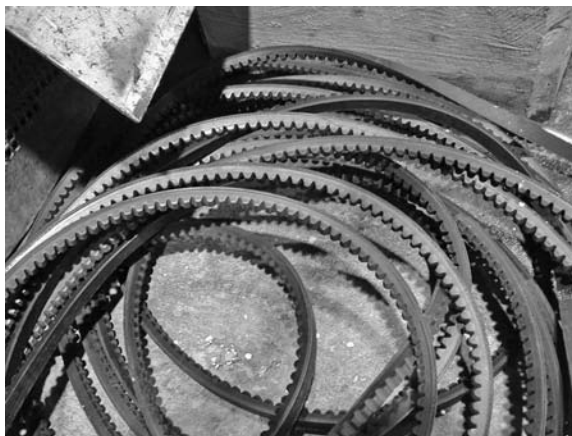
PHOTO 9.5 This is a pile of belts that has just been removed from a large fan. The elastomer on the sheave contact surfaces is shiny and polished, proof that the belts have been slipping.

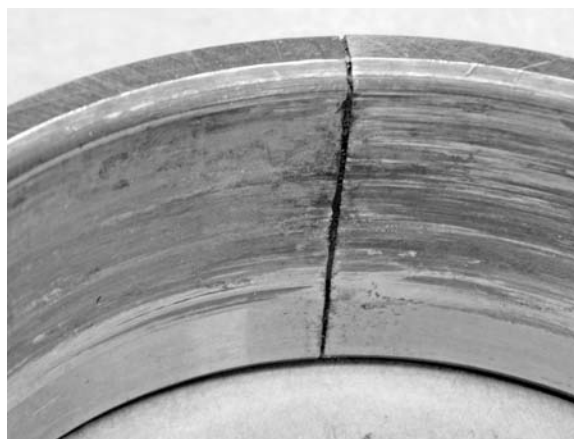
PHOTO 10.2 This shows the shaft fit from a through-hardened bearing. The crack extends to the rolling surface and a catastrophic failure is not far away.

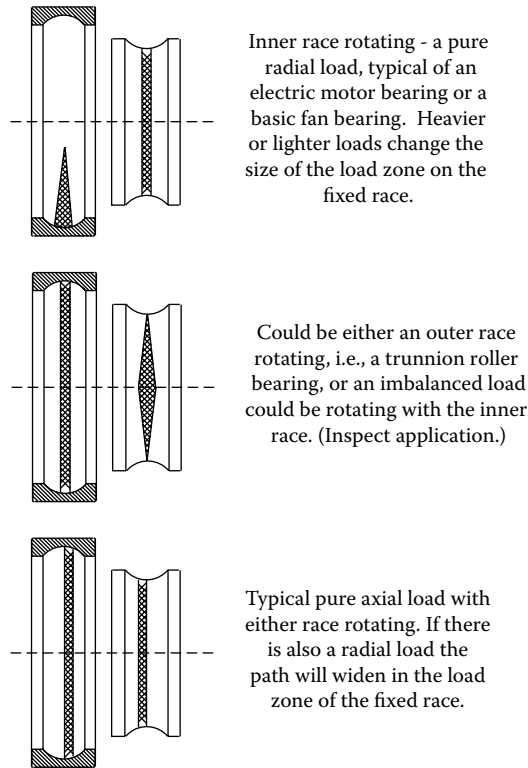
FIGURE 10.6 Typical normal load zones in a ball bearing.

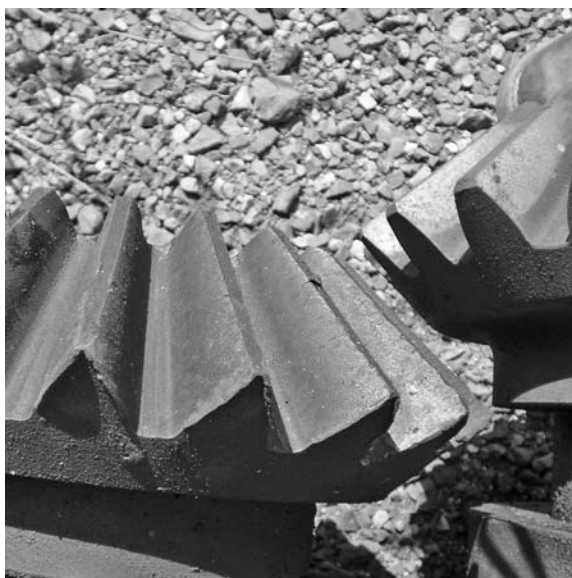
PHOTO 11.11 A through-hardened steel mill gear with heavily worn teeth that show rolling damage.
